Replacement of Missing Teeth with **Sinfony™** Light Curing Composite and Glass Fibres

## From Prep to Crown – Dental Materials in Daily Practice

Luca Ortensi; Bologna, Italy

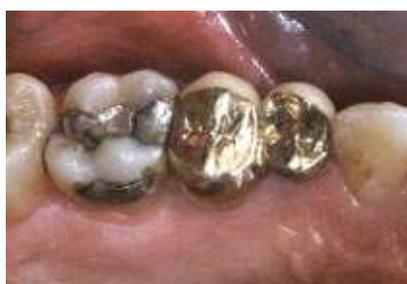
Fig. 1: Preoperative view shows metal-resin bridge and amalgam restoration to be removed.

A 25-year old male manifested pain to the second left bicuspid. The clinical and radiographic examination revealed a metal-resin crown on the second bicuspid with an extension which replaced the first bicuspid. An amalgam restoration was present on the first molar (Fig. 1, Fig. 2). The second bicuspid presented a carious lesion. A fibre reinforced bridge between the second premolar and the palatal surface of the canine was suggested to the patient as an option of treatment as replacement of the metal-resin bridge after curing of the carious lesion. An indirect composite restoration was proposed to replace the old amalgam filling on the molar. The patient accepted the treatment plan.

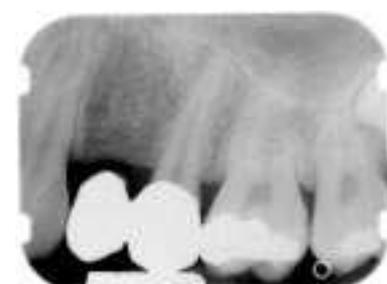
Fig. 2: X-ray shows infiltration of the carious lesion at the margin of the crown (distal zone).

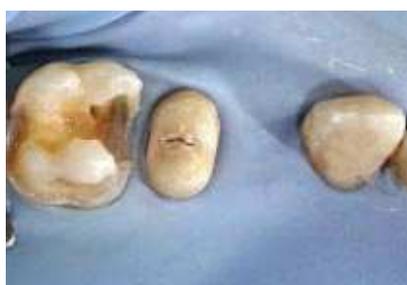
Fig. 3: The operative area was isolated with rubber dam. It is possible to see the carious lesion in the distal zone of premolar.

During the following appointment, the teeth were isolated with a rubber dam, and the preexisting amalgam restoration and the metal-resin bridge were removed with high-speed tungsten carbide burs (Fig. 3). The carious lesion, present on the second bicuspid, was eliminated and a build-up was carried out with a flowable composite (Filtek™ Flow, the flowable composite from 3M ESPE) (Fig. 4).

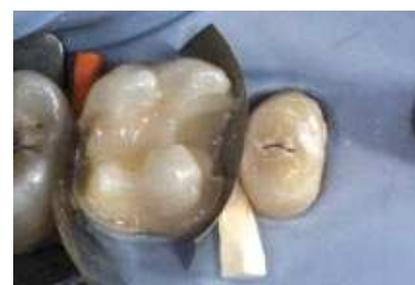
Fig. 4: Build-up of the first molar with flowable composite.

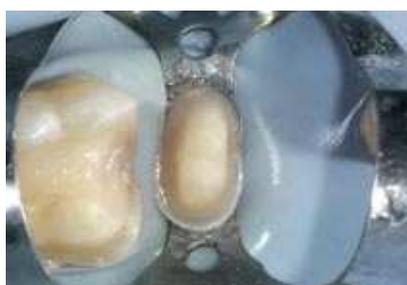
Fig. 5: Preparation of the premolar. An adhesive preparation was made with butt margin and rounded surfaces.

The first molar was prepared with a diamond bur to obtain butt joint margins and rounded internal line angles. The premolar was prepared with butt margin and rounded surfaces (Fig. 5, Fig. 6). Approximately 0,7 mm of palatal enamel was removed from the canine. An impression of the prepared teeth was taken using the polyether impression material Impregum™ Penta™ H/L DuoSoft from 3M ESPE (Fig. 7). The provisional restorations were fabricated with

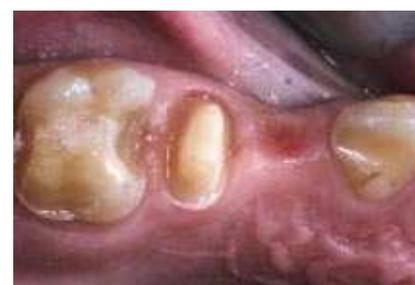
Fig. 6: Tooth preparation was performed for proper fibre-reinforced composite bridge and overlay.

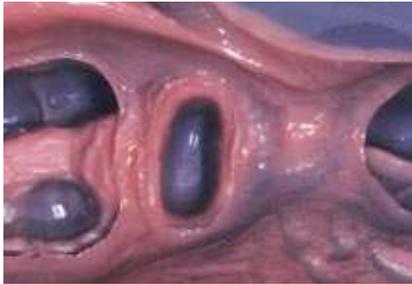
*Fig. 7: A polyether impression of the preparation was obtained.*

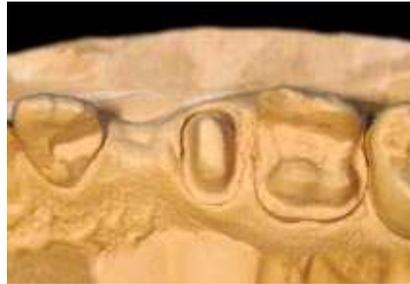
*Fig. 8: Master model. It is possible to see the preparation of the distal surface of the canine.*

Protemp™ 3 Garant (3M ESPE) and were cemented with a eugenol-free cement. The impression was poured with high-strength dental stone for master model fabrication (Fig. 8).

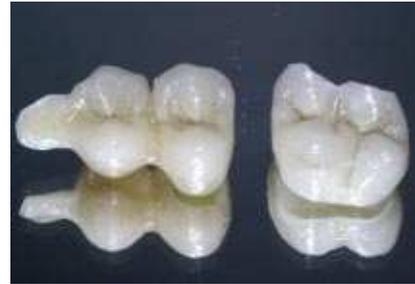
*Fig. 9: The external aspect of the fibre-reinforced composite bridge was completed and returned to the clinician for try-in.*

The fibre-reinforced composite bridge and the indirect composite restoration were constructed on the master model using a layering technique (Sinfony, 3M ESPE; Vectris, Ivoclar-Vivadent) (Fig. 9).

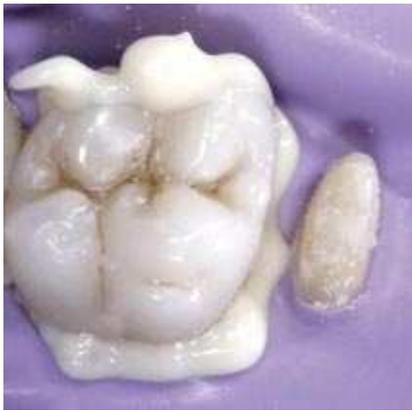
*Fig. 10: Cementation of the overlay with RelyX<sup>™</sup> Unicem Self Adhesive Universal Resin Cement.*

At the cementation appointment the restorations were tried-in and checked for the color match prior to placing the rubber dam. The abutments were sandblasted with 50 microns aluminium oxide to obtain a cleaned surface. The overlay was cemented with RelyX Unicem (Fig. 10). The fibre-reinforced composite bridge was cemented with two different systems at the same time. We used RelyX Unicem for the premolar and the RelyX<sup>™</sup> ARC Adhesive Resin Cement for the canine, due to the large amount of enamel present on the canine preparation. Before the cementation the palatal surface of the canine was acid-etched for 30 seconds and treated with an adhesive system (Scotchbond<sup>™</sup> 1, 3M ESPE). Excess

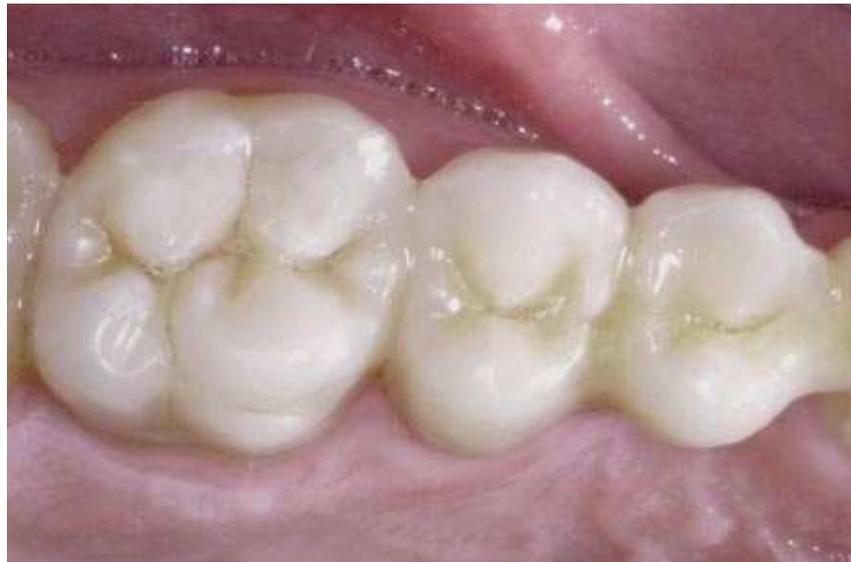
*Fig. 11: Postoperative occlusal view of the fibre-reinforced composite fixed partial denture. Note the good integration and the natural effect obtained by the restoration.*

luting material was removed with a small brush and floss. The luting composite was light-cured for 120 seconds. Following the removal of the rubber dam, the occlusion was adjusted with diamond finishing burs (Fig. 11).
